Inspection Report

Property Address:
123 Raspberry Lane Sample
New City NY 10956

EASYgreen Home Services

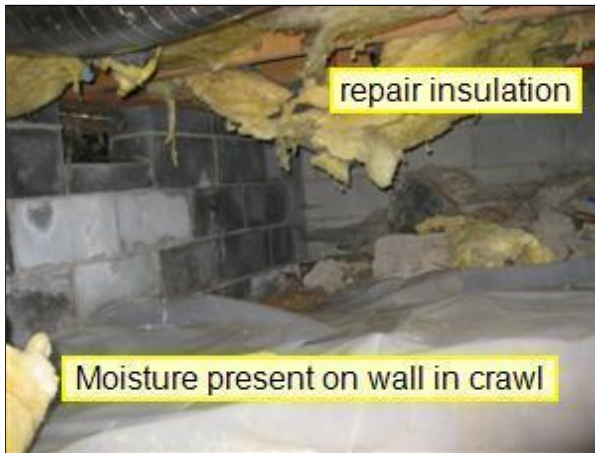
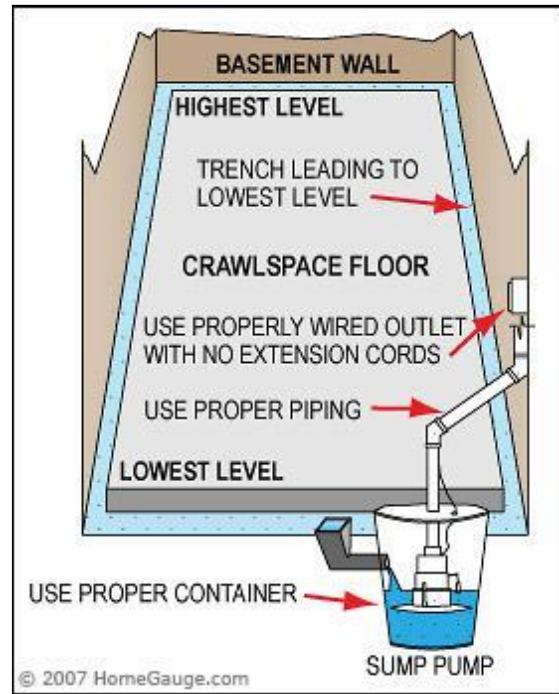
(1) White efflorescence (powder substance) on block wall indicates moisture is in contact with the masonry. This does not necessarily indicate that intrusion will occur. I recommend checking the gutters and the downspout drain lines for proper operation. Also, a water proofing paint could be applied to the interior side of the block if necessary. Efflorescence is found on many homes without water intrusion occurring inside the home. But, it should alert you to the possibility that future steps may be needed.

(2) Visible signs of water intrusion in the crawlspace (along front of home) are present from dampness along the block wall. I am unable to determine the extent of intrusion or how often it occurs. Cross ventilation may help as the crawls has no ventilation. I recommend further investigation or correction by a qualified licensed contractor or water infiltration specialist. Refer to the diagram as a guide if a drainage system is needed.

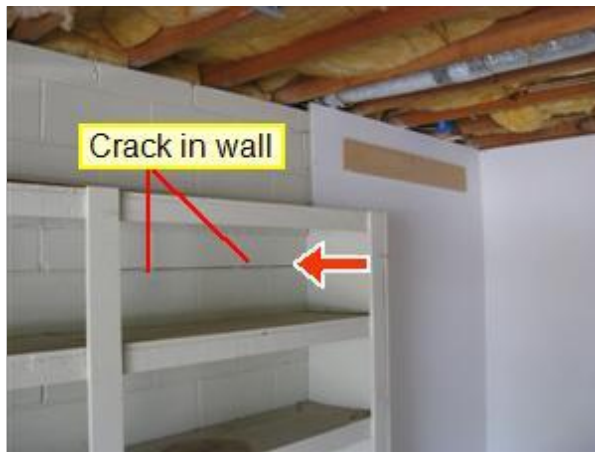
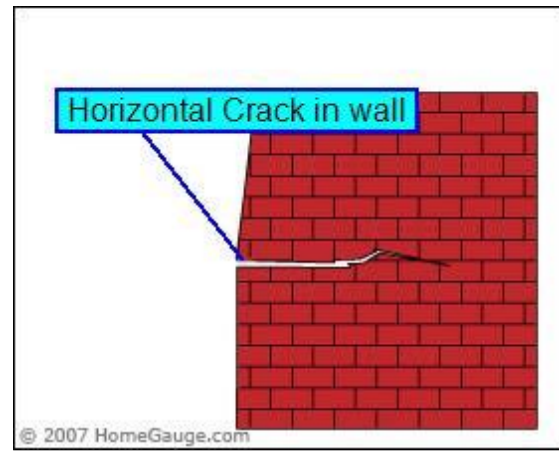
- There is a horizontal crack(s) in the foundation wall at the left side (facing front). These cracks do not appear significant to require repairs at this time. This is my opinion and you should seek a second opinion by a licensed qualified person.

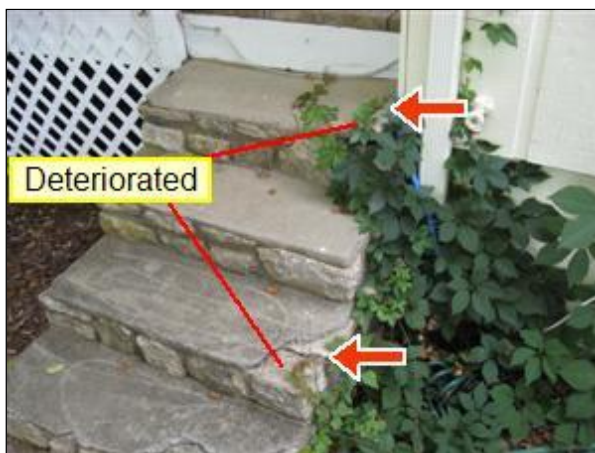
2.3 Picture 1

The step tread on steps on the deck at the rear of home are deteriorated. A repair or replacement is needed. A skilled masonry contractor should perform the work.

A handrail may be needed per municipal requirements

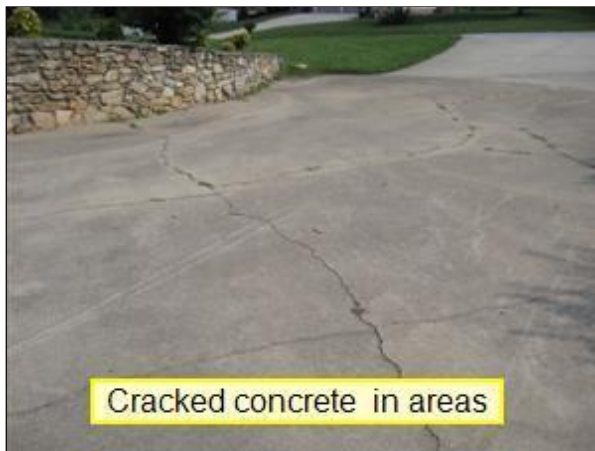
2.4 Picture 1

- (1) The concrete drive at the front of home is pitted in areas and has settlement cracks. Further deterioration can occur if not repaired. A qualified contractor should inspect and repair as needed.

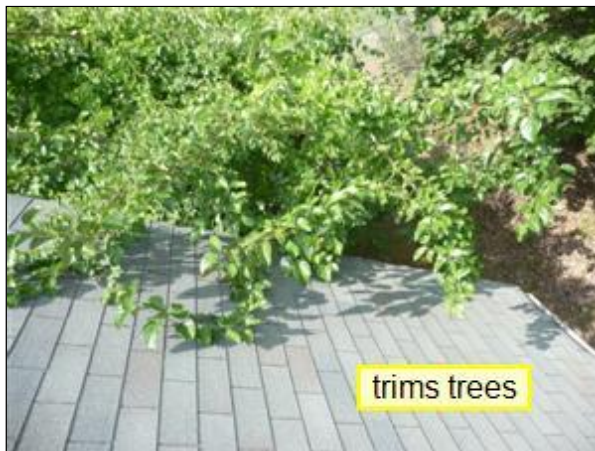
2.4 Picture 2

- (2) The tree limbs that are in contact with roof or hanging near roof should be trimmed.

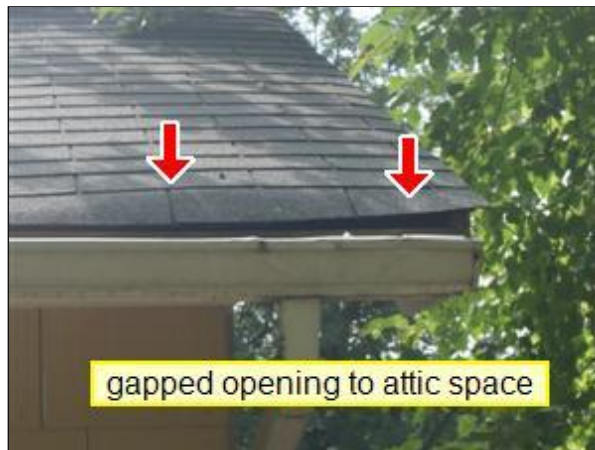
2.5 Picture 1

A gap between the fascia and roof sheathing exists along the rear fascia which may allow insects or pests to enter attic. This should be corrected.

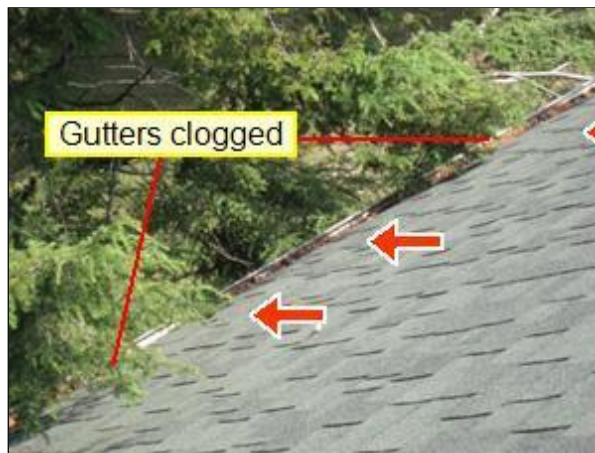
3.3 Picture 1

- The gutter needs cleaning of debris at the virtually all areas where gutters are installed. Gutters that drain poorly or clogged can lead to many costly problems such as deterioration of fascia, soffit or roof edge. It can also cause gutters to pull loose and lead to possible water intrusion. A qualified person should repair or replace as needed.

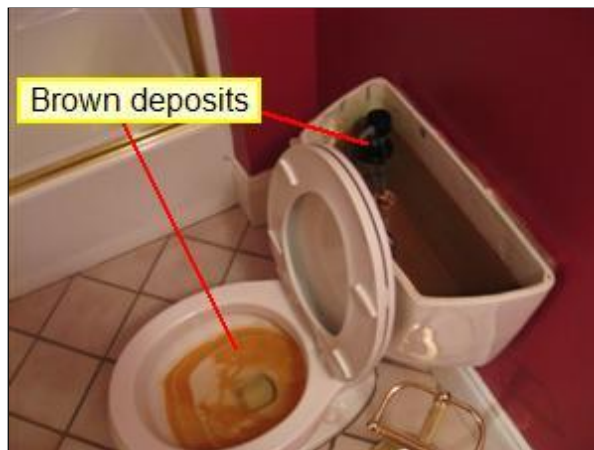
4.1 Picture 1

Brown deposits are on the plumbing fixtures which indicates a filter may be needed. Filter in place and appears dirty but I am unable to determine if you need a different or additional filter. I did not test water for bacteria or other. I recommend contacting a water filtration company.

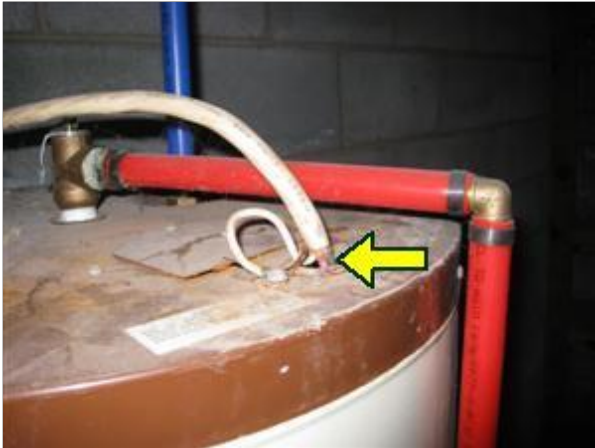
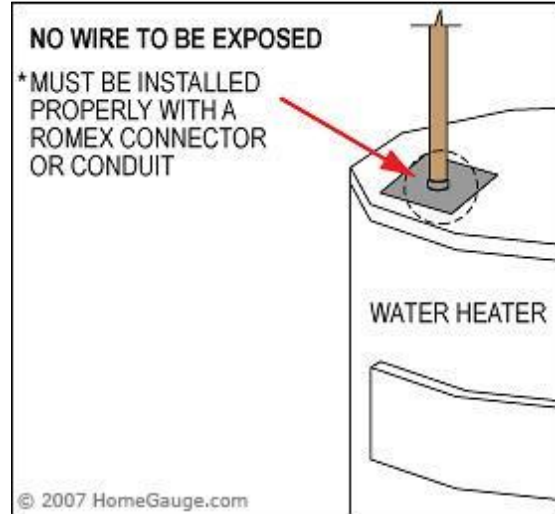
- The wiring for the water heater missing romex connector. Electrical issues are considered a hazard until repaired. I recommend a licensed electrician correct as necessary.

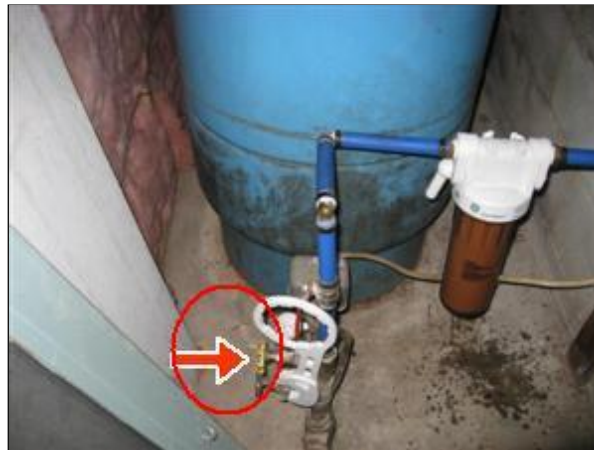
The main shut off is the yellow knob located in the basement at the pressure tank. This is for your information.

4.3 Picture 1 In basement

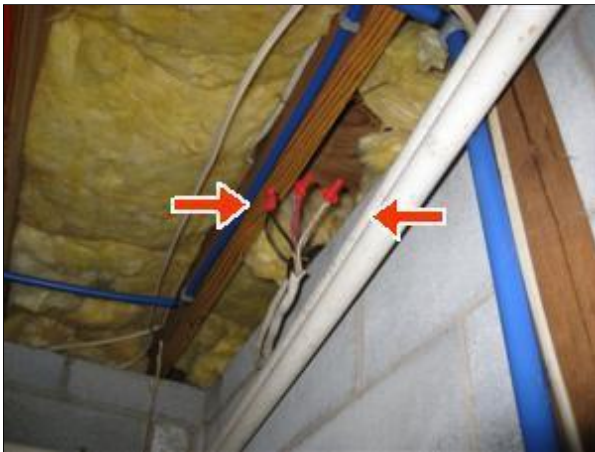
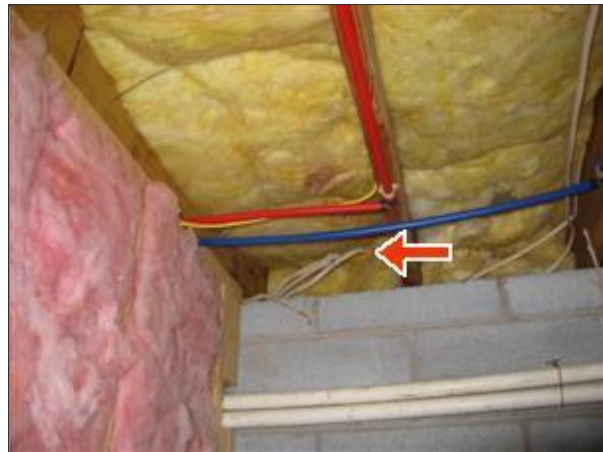
Several loose wire ends needs placing inside a box with a cover-plate in the basement at the pressure tank of well. I recommend repair as needed.

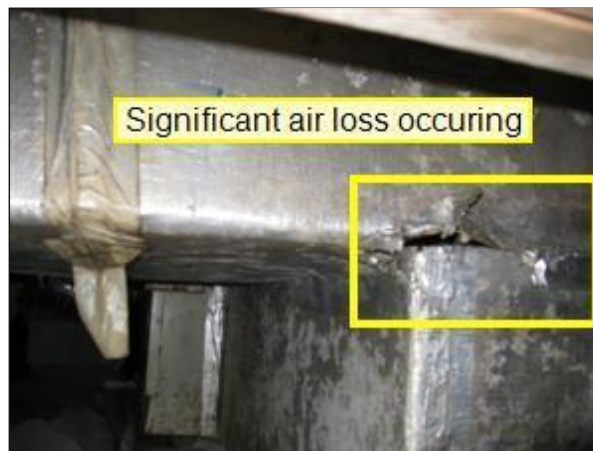
The supply duct pipe or main plenum is failing in the crawlspace. Energy loss is occurring in crawlspace and immediate correction is needed. A licensed HVAC contractor should service or repair unit.

6.3 Picture 1 crawlspace new addition

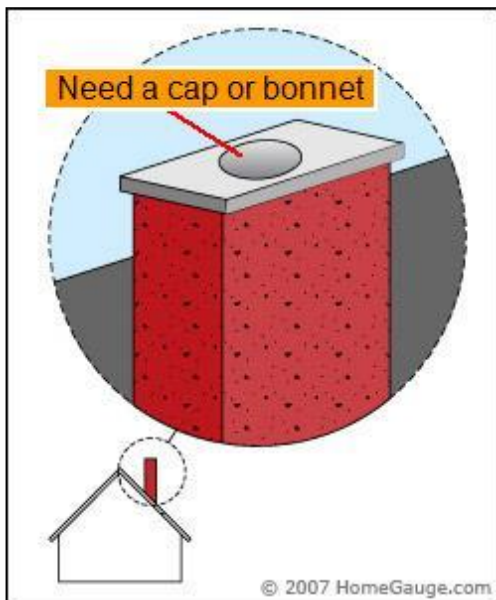
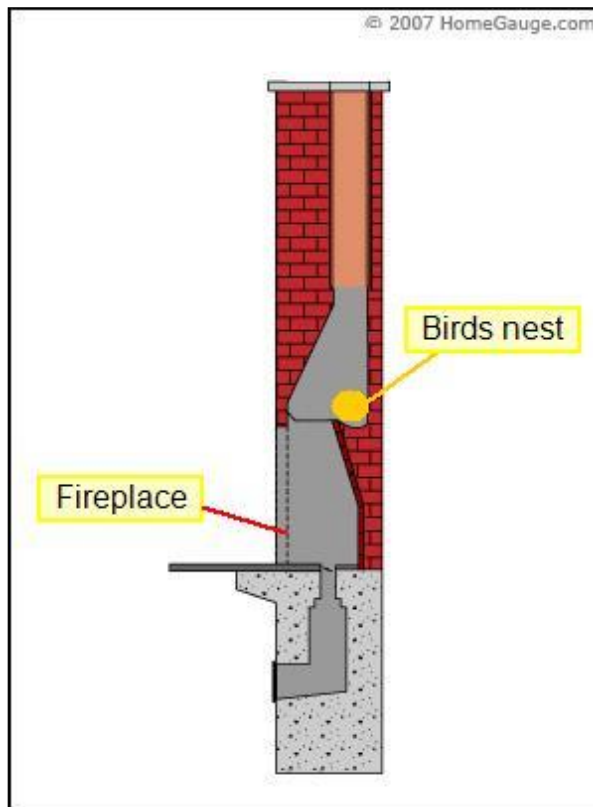
An active birds nest is currently in chimney. It is recommended to install a cap or bonnet on chimney this fall.

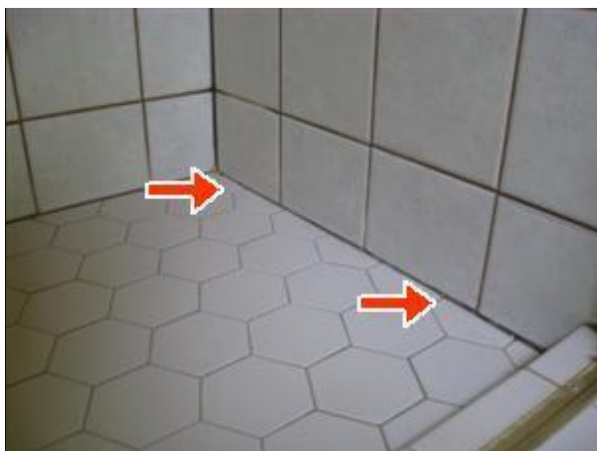
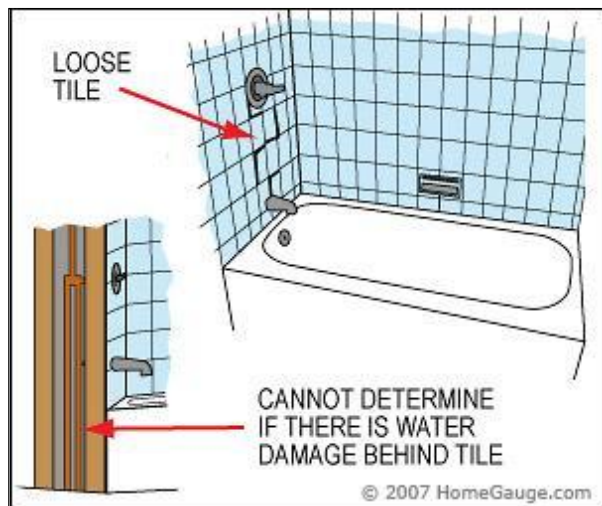
- Tile at shower pan and wall surround are loose and missing mortar or grout and sealer at the upstairs bath. Repairs are needed to prevent water damage to shower/bath. A qualified person should repair or replace as needed.

8.2 Picture 1 Upstairs bath

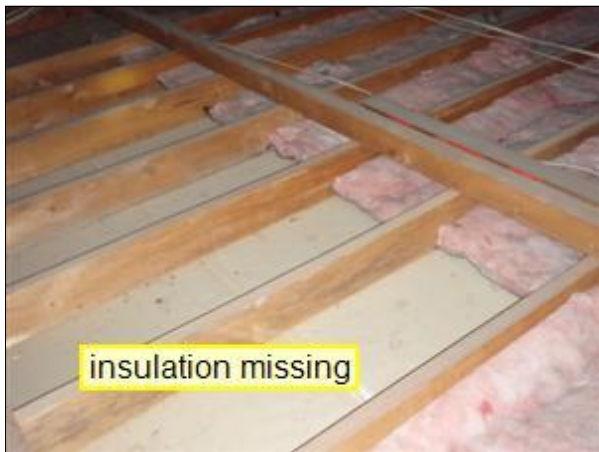
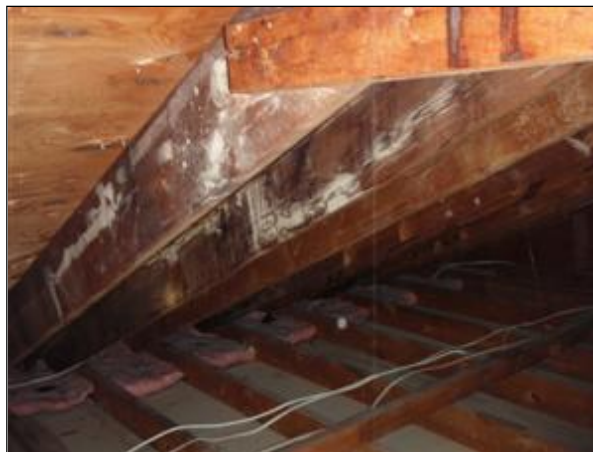
(1) Attic insulation is missing in the space above the kitchen, dining room and part of living room. It appears to have been removed at one time and never replaced, possibly on a past repair project. This represents about 1/3 of the attic insulated space and probably caused or contributed to deteriorated roof sheathing and fungi like stains on the roof rafters. We did not inspect, test or determine if this growth is or is not a health hazard. The underlying cause is moisture or dampness. I recommend you contact a mold inspector or expert for investigation or correction if needed.

This insulation should be replaced by a qualified contractor and additional insulation added to the existing.

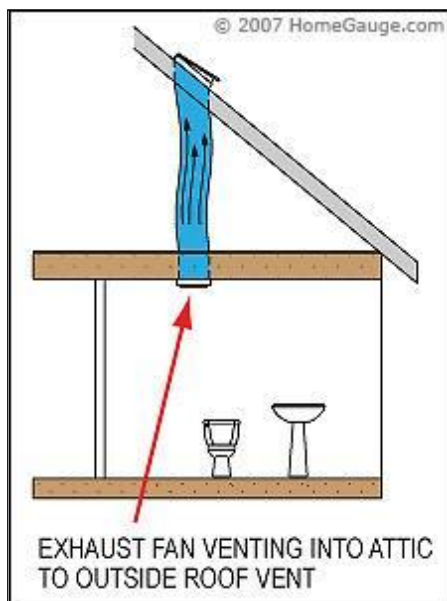
9.4 Picture 1

- 🔧 The Exhaust fan does not vent to outside at the hall bath and master bath. Vent pipes should terminate outside and not in the attic. Many homes have their vent pipe poised at the roof vent such as yours. It is up to you to determine whether or not this is a concern or needs further consideration from a general contractor. A qualified contractor should inspect and repair as needed.

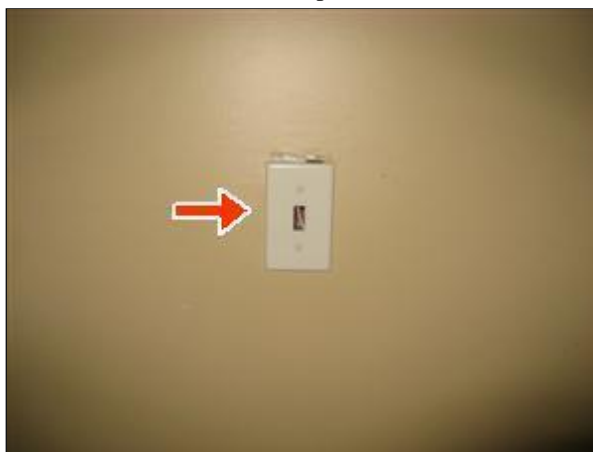
9.5 Picture 1

- 🔧 Wall switch for room fan in wall has been removed. It is inoperable.

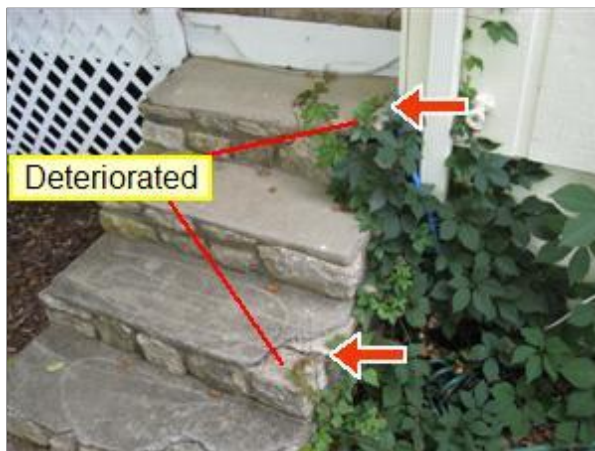
2.3 Picture 1

- The step tread on steps on the deck at the rear of home are deteriorated. A repair or replacement is needed. A skilled masonry contractor should perform the work.

A handrail may be needed per municipal requirements

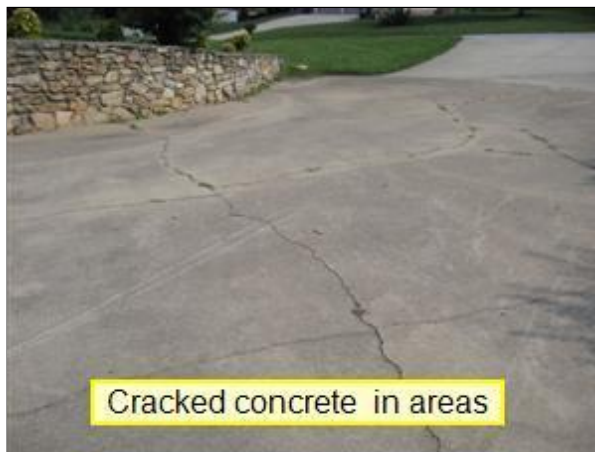
2.4 Picture 1

- (1) The concrete drive at the front of home is pitted in areas and has settlement cracks. Further deterioration can occur if not repaired. A qualified contractor should inspect and repair as needed.

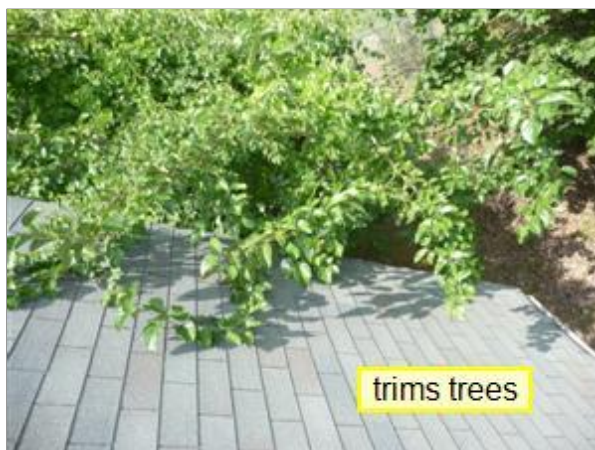
2.4 Picture 2

- (2) The tree limbs that are in contact with roof or hanging near roof should be trimmed.

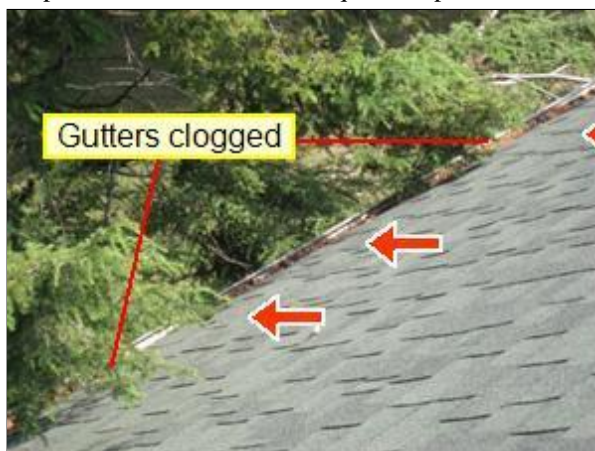
- The gutter needs cleaning of debris at the virtually all areas where gutters are installed. Gutters that drain poorly or clogged can lead to many costly problems such as deterioration of fascia, soffit or roof edge. It can also cause gutters to pull loose and lead to possible water intrusion. A qualified person should repair or replace as needed.

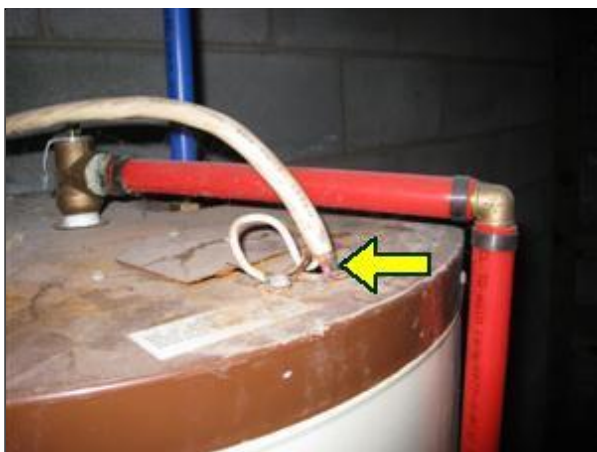
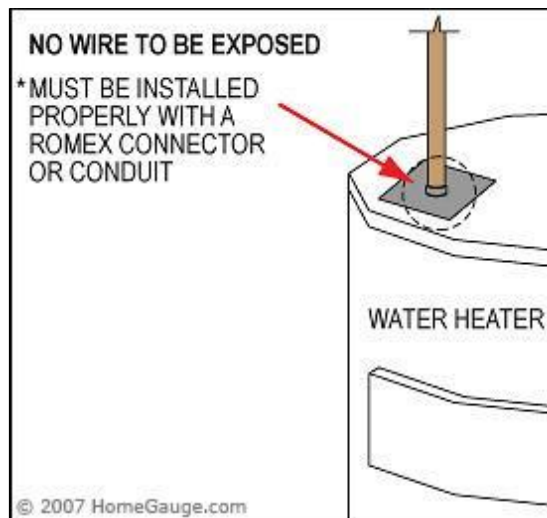
- The wiring for the water heater missing romex connector. Electrical issues are considered a hazard until repaired. I recommend a licensed electrician correct as necessary.

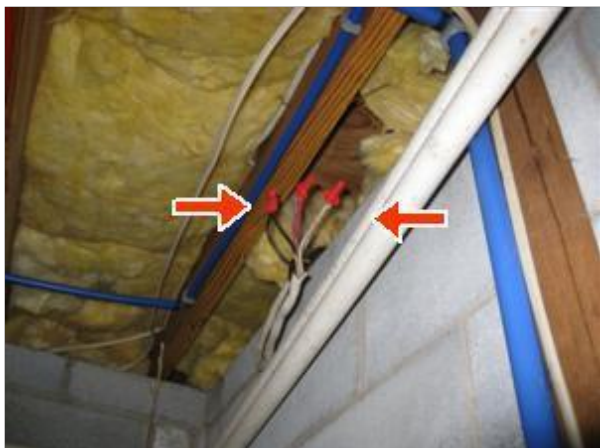
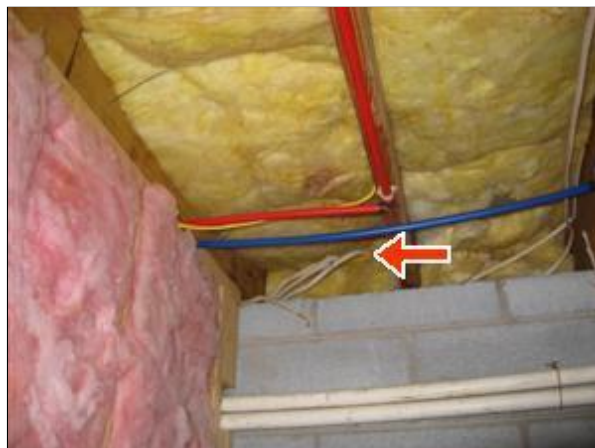
- Several loose wire ends needs placing inside a box with a cover-plate in the basement at the pressure tank of well. I recommend repair as needed.

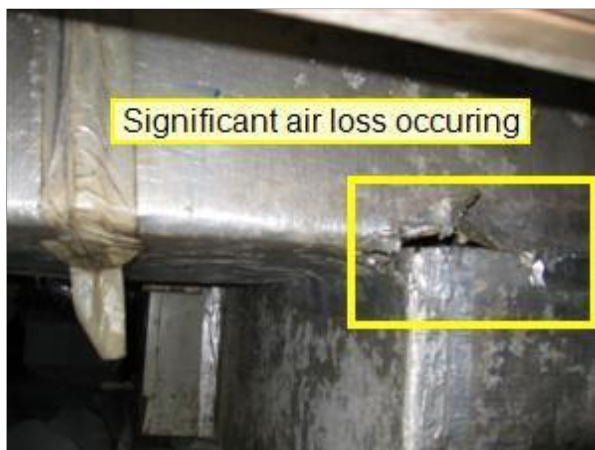
- The supply duct pipe or main plenum is failing in the crawlspace. Energy loss is occurring in crawlspace and immediate correction is needed. A licensed HVAC contractor should service or repair unit.

6.3 Picture 1 crawlspace new addition

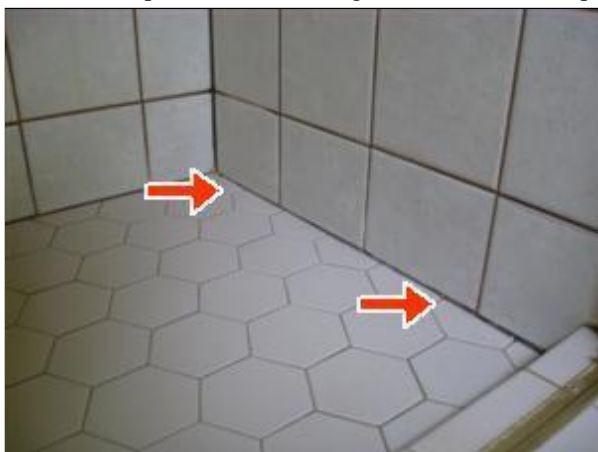
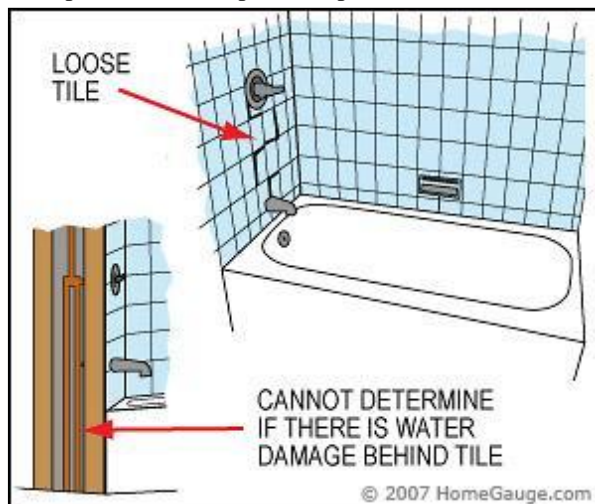
- Tile at shower pan and wall surround are loose and missing mortar or grout and sealer at the upstairs bath. Repairs are needed to prevent water damage to shower/bath. A qualified person should repair or replace as needed.

8.2 Picture 1 Upstairs bath

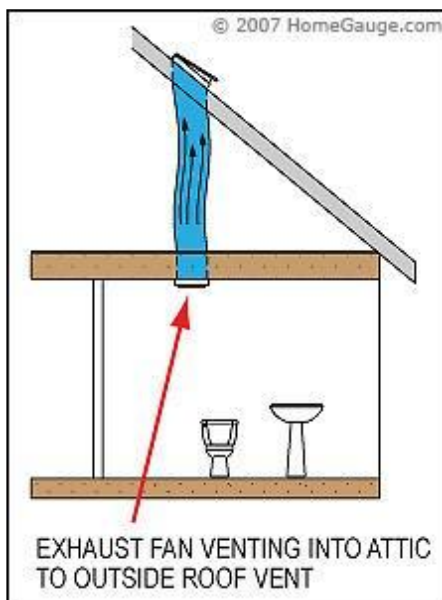
9.4 Picture 1

- The Exhaust fan does not vent to outside at the hall bath and master bath. Vent pipes should terminate outside and not in the attic. Many homes have their vent pipe poised at the roof vent such as yours. It is up to you to determine whether or not this is a concern or needs further consideration from a general contractor. A qualified contractor should inspect and repair as needed.

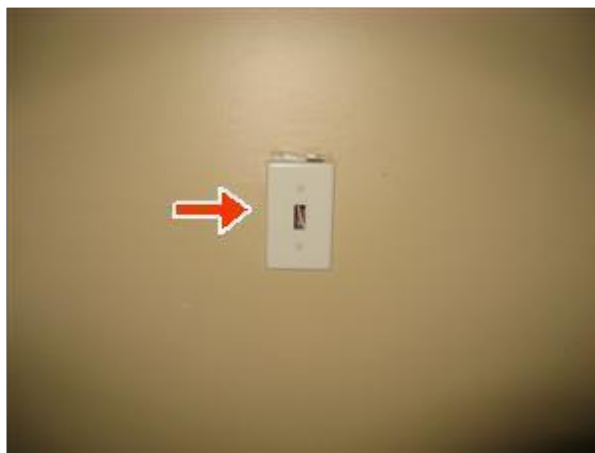
9.5 Picture 1

- Wall switch for room fan in wall has been removed. It is inoperable.

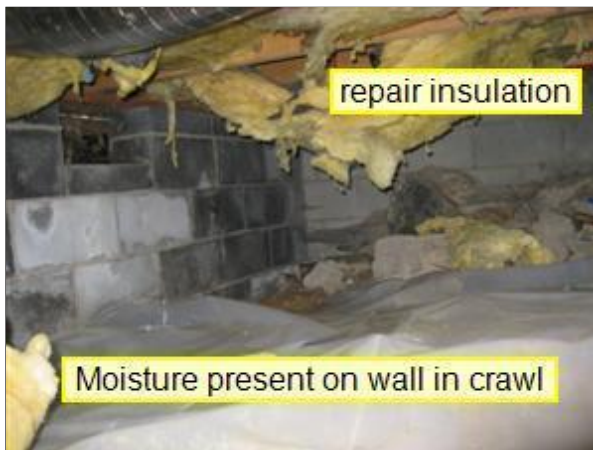
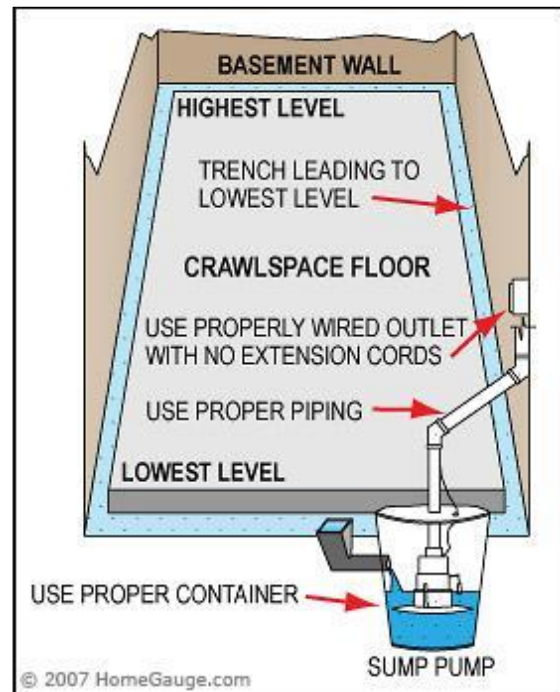
(2) Visible signs of water intrusion in the crawlspace (along front of home) are present from dampness along the block wall. I am unable to determine the extent of intrusion or how often it occurs. Cross ventilation may help as the crawls has no ventilation. I recommend further investigation or correction by a qualified licensed contractor or water infiltration specialist. Refer to the diagram as a guide if a drainage system is needed.

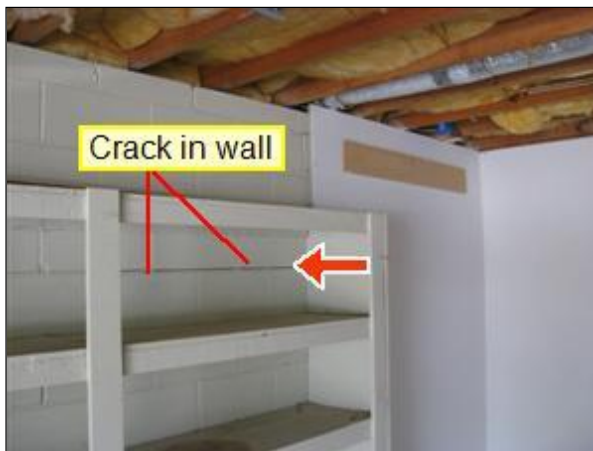
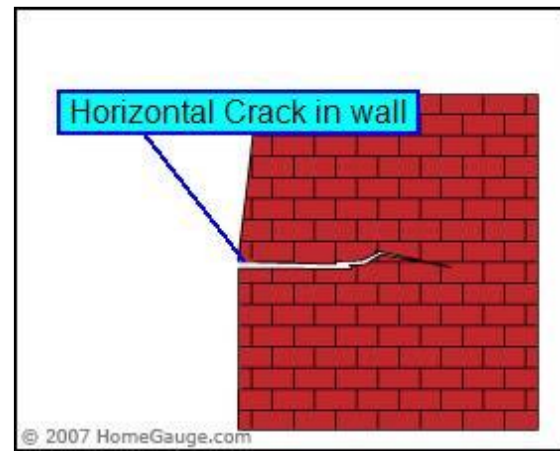
- There is a horizontal crack(s) in the foundation wall at the left side (facing front). These cracks do not appear significant to require repairs at this time. This is my opinion and you should seek a second opinion by a licensed qualified person.

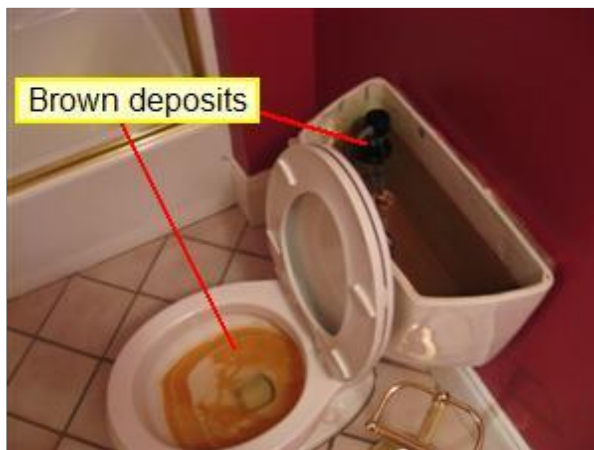
4.1 Picture 1

- 🔍 Brown deposits are on the plumbing fixtures which indicates a filter may be needed. Filter in place and appears dirty but I am unable to determine if you need a different or additional filter. I did not test water for bacteria or other. I recommend contacting a water filtration company.
